**RE: Warrior River Fish Kill**

## Bankhead Reservoir Fish Kill Investigation

Parrish, Alabama

June 16th, 2016

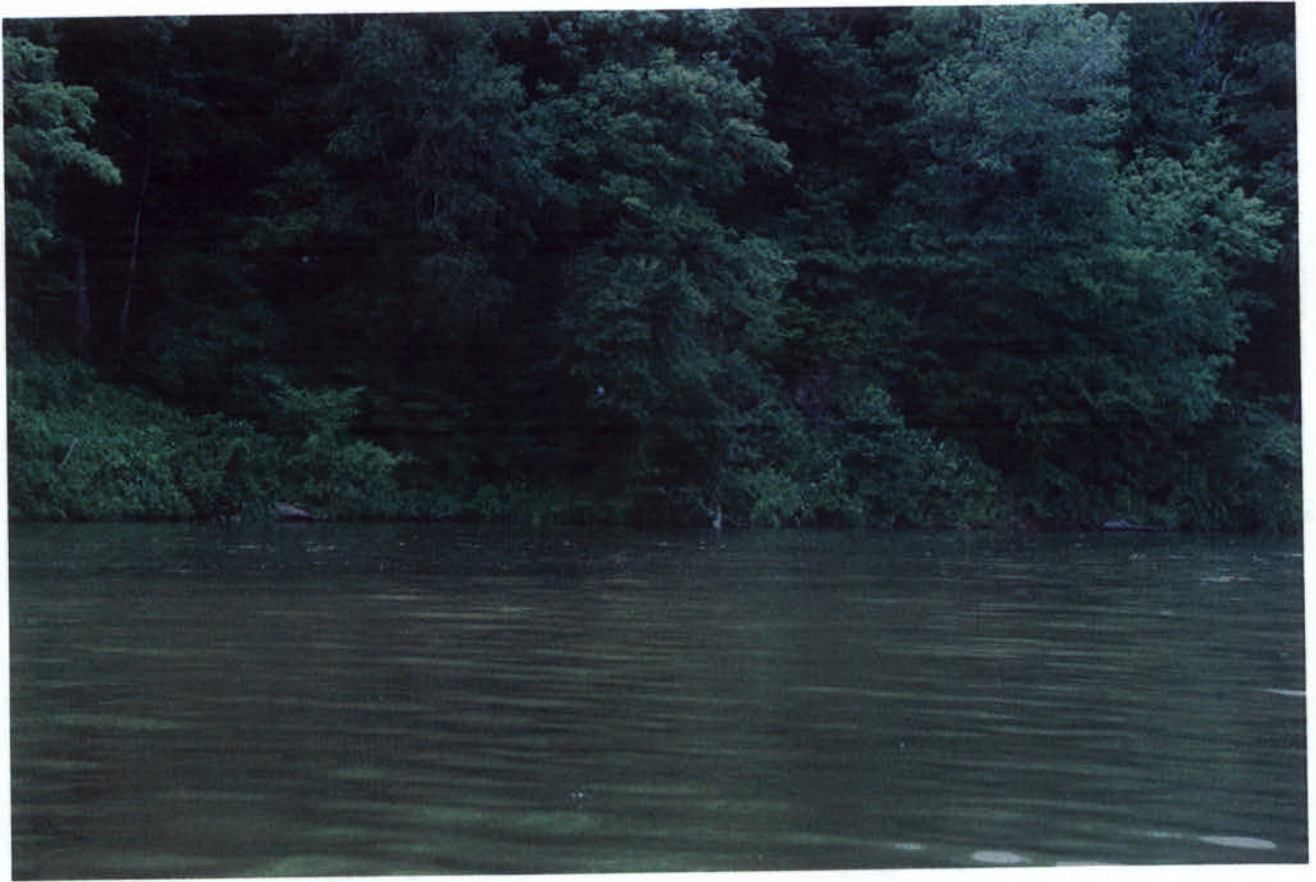
Figure 2. Bankhead Reservoir Fish Kill, Walker County June 16<sup>th</sup> 2016.

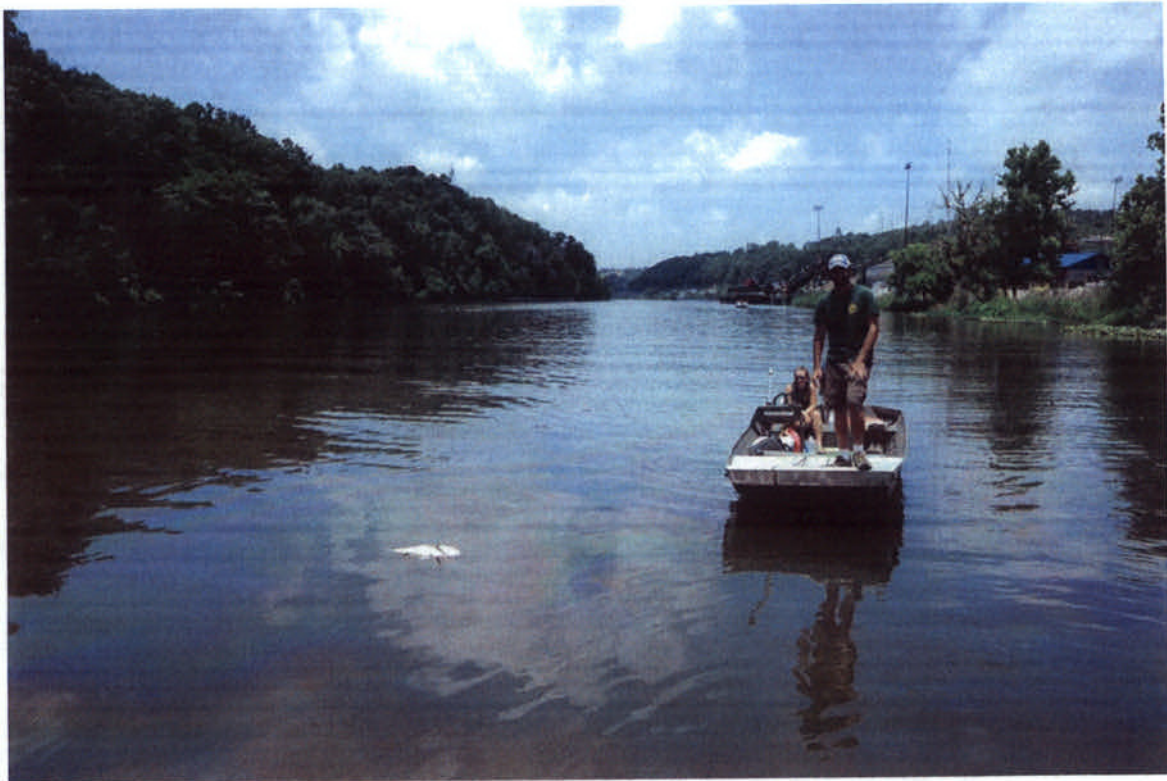
Figure 3. Oil sheen in the area of the Bankhead Reservoir Fish Kill, Walker County June 16<sup>th</sup> 2016.

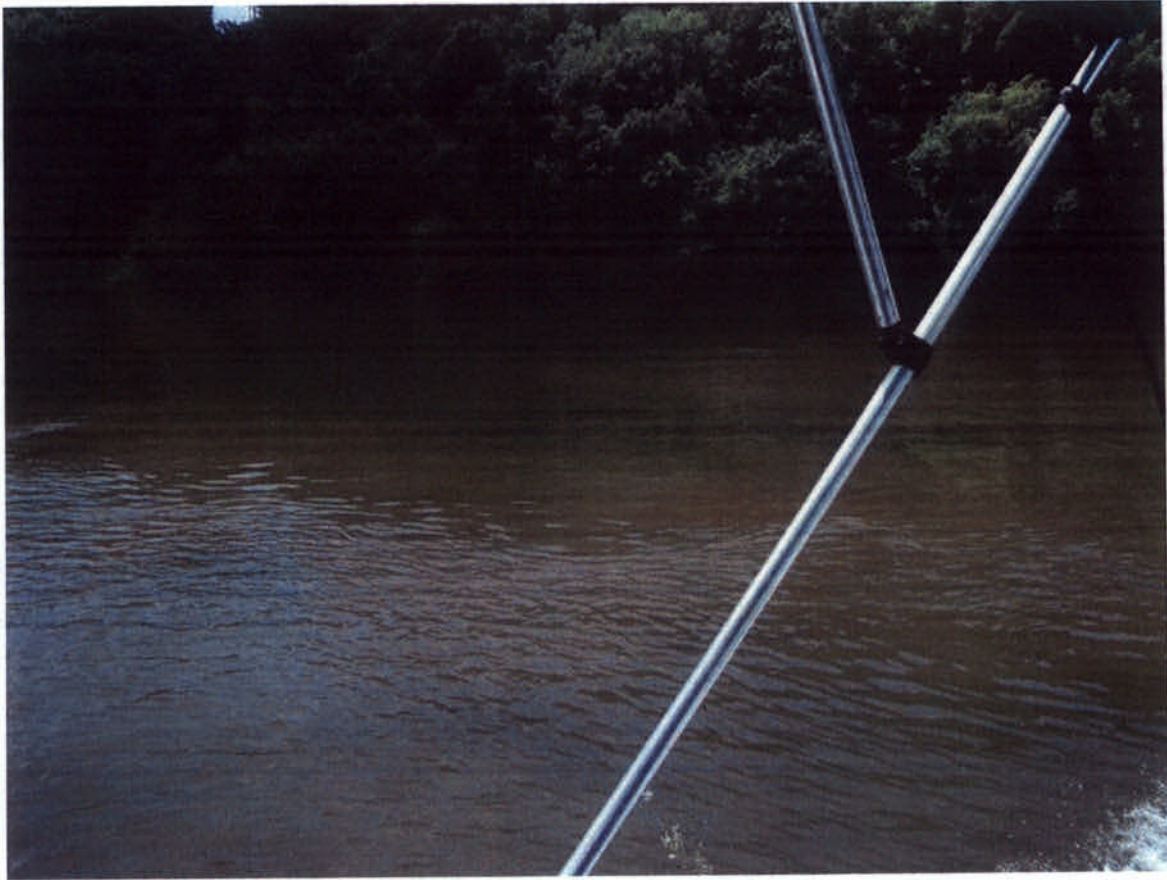
Figure 4. Turbid water entering Bankhead Reservoir from the Gorgas Steam Plant Discharge Canal, Walker County June 16<sup>th</sup> 2016.

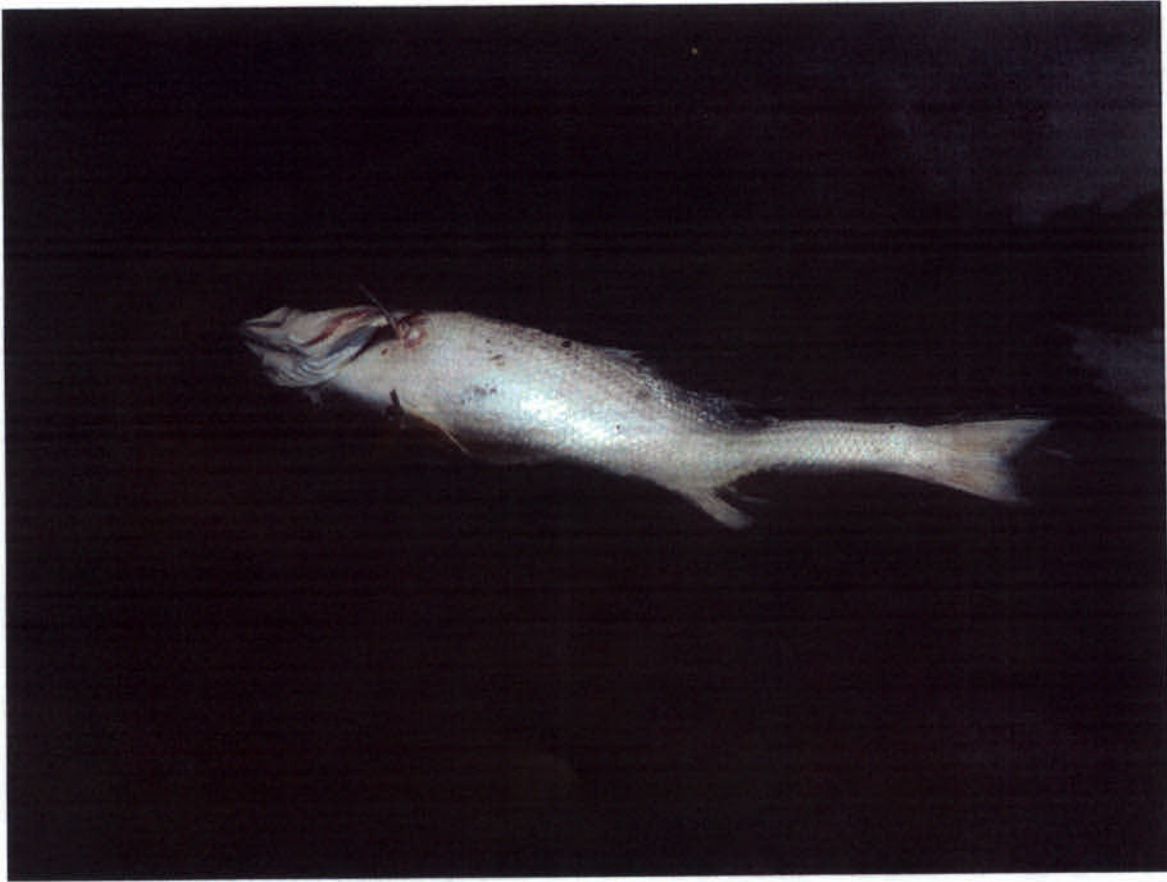
Figure 2. Dead Striped Bass at the Bankhead Reservoir Fish Kill, Walker County June 16<sup>th</sup> 2016
