**Re: Notice of Intent to File Citizen Suit for Violations of the Clean Water Act
and the Resource Conservation and Recovery Act at the Maxine Mine near
Praco, Alabama**

Figure 1

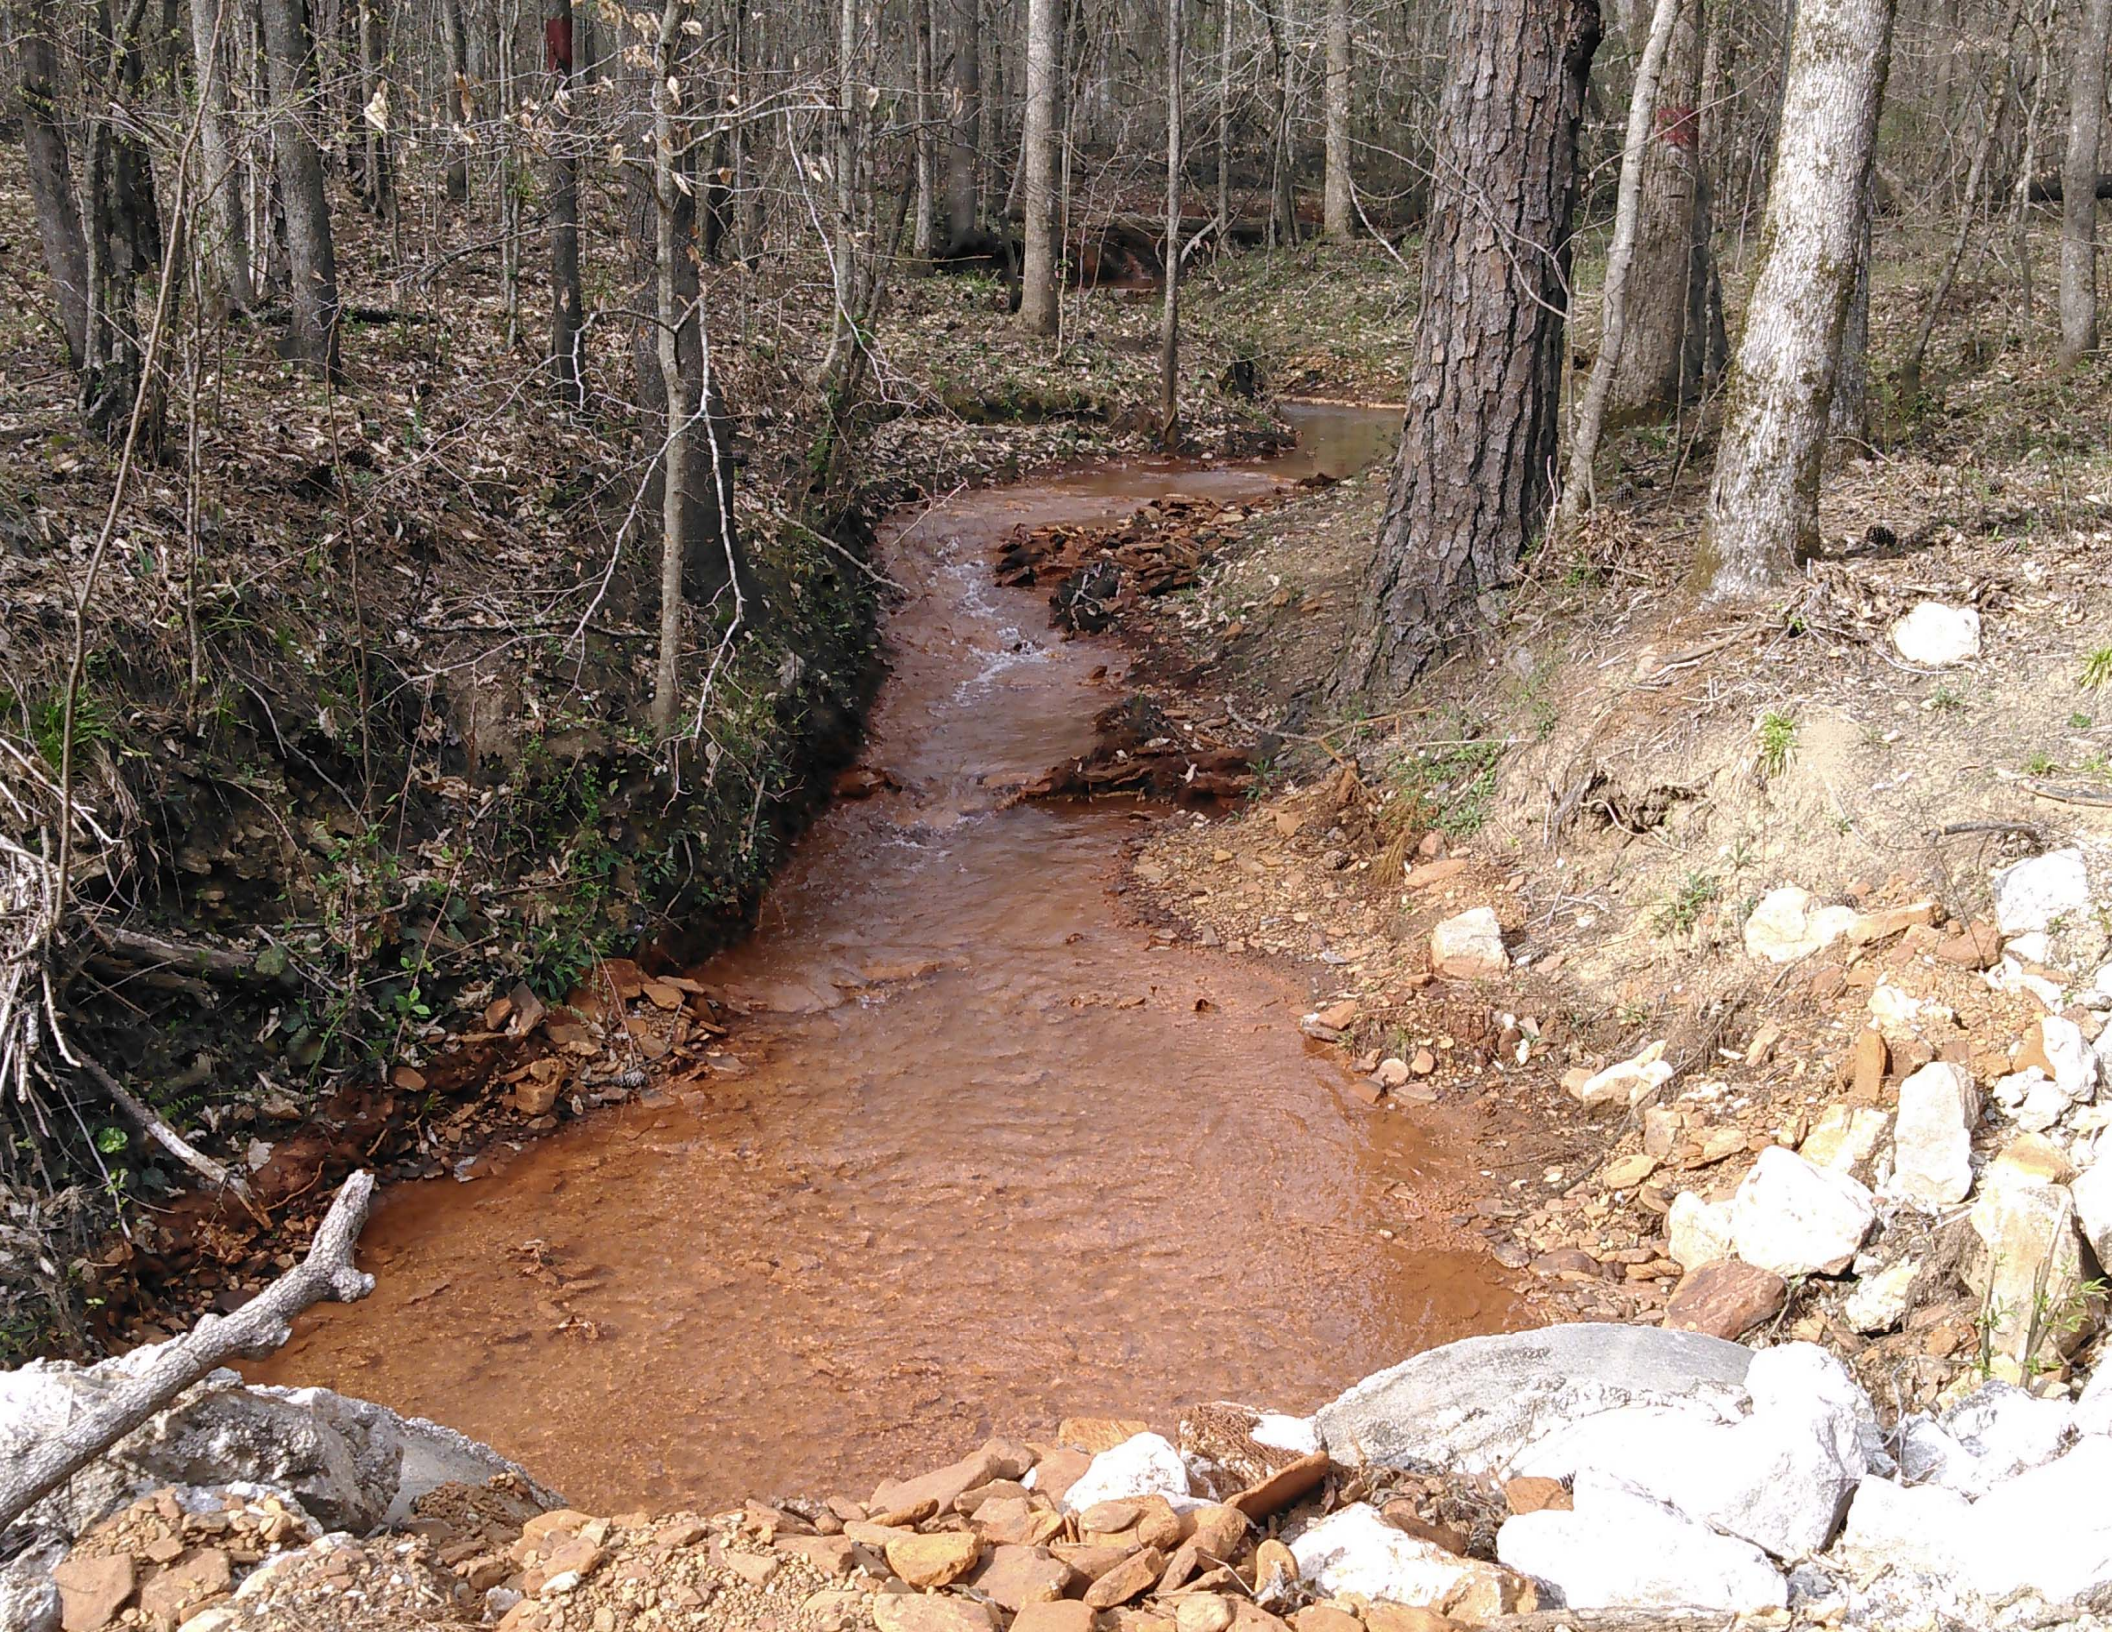
Figure 5

In addition to the GOB pile and its related system of drainage ditches and sediment basins, the underground mine works are sufficiently “discernable, confined, and discrete” to constitute a point source under the CWA. *Beartooth Alliance*, 904 F.Supp 1168 (holding that AMD seeping from mine openings or fissures is an unpermitted discharge of pollutants from a point source). Polluted water from the mine pool is escaping the mine works and entering Brown’s Creek on a regular basis in sufficient quantities to turn the substrate of the tributary orange. (*Figure 5*.)
